CHAPTER 3

HARLEM RIVER

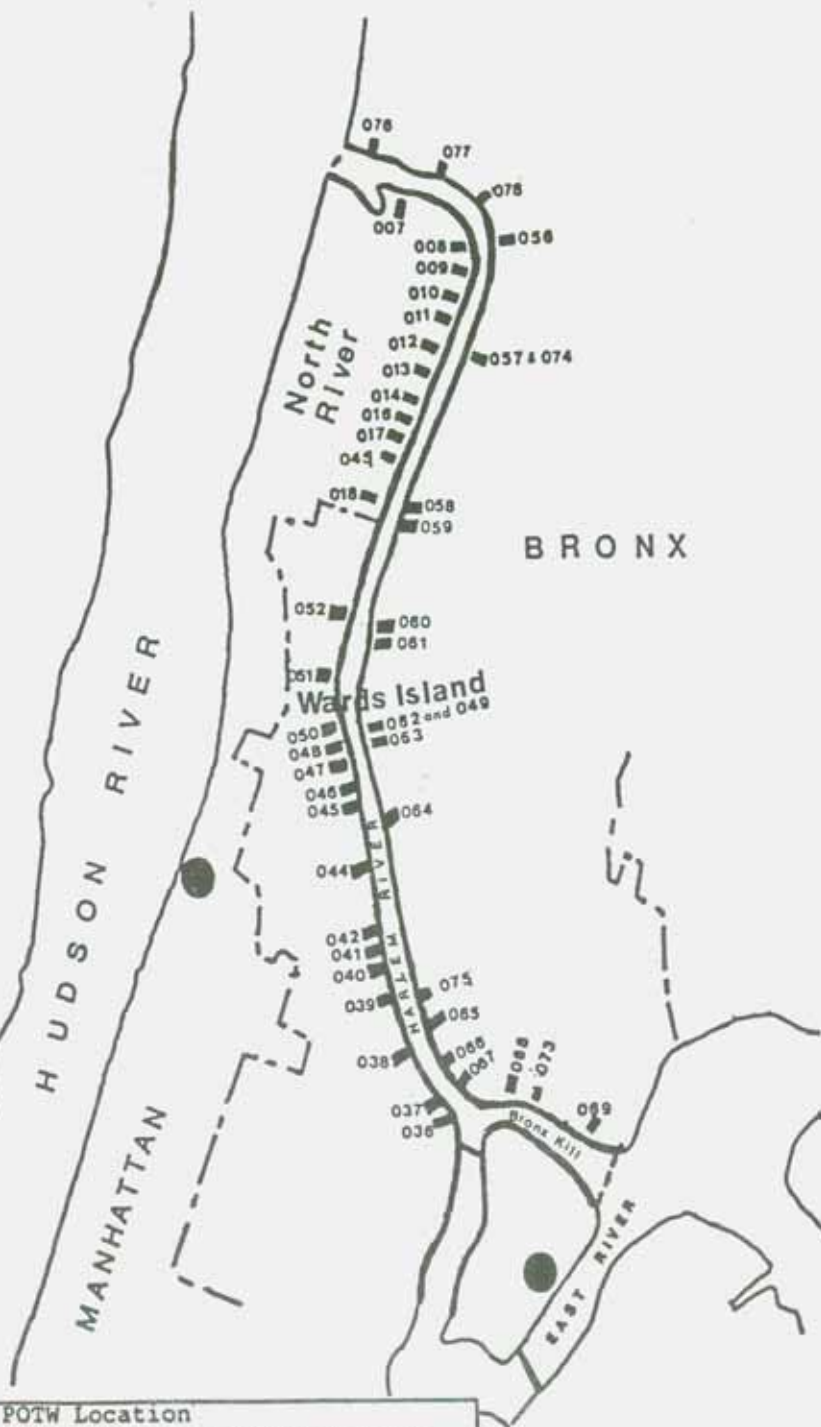
MAP 3-1

Approximately 48 combined sewer outfalls discharge into the Harlem River and Bronx Kill. These CSOs are primarily in the Wards Island drainage basin, although 12 outfalls on the upper part of the River fall within the North River drainage basin (permit NY0026247). The outfalls in this area are shown on Map 3-1 and listed on Table 3-1.
